Automated Eddy Current Inspection on Space Shuttle Hardware

John Hartman and Jeremy Felker

ATK Launch Systems Group

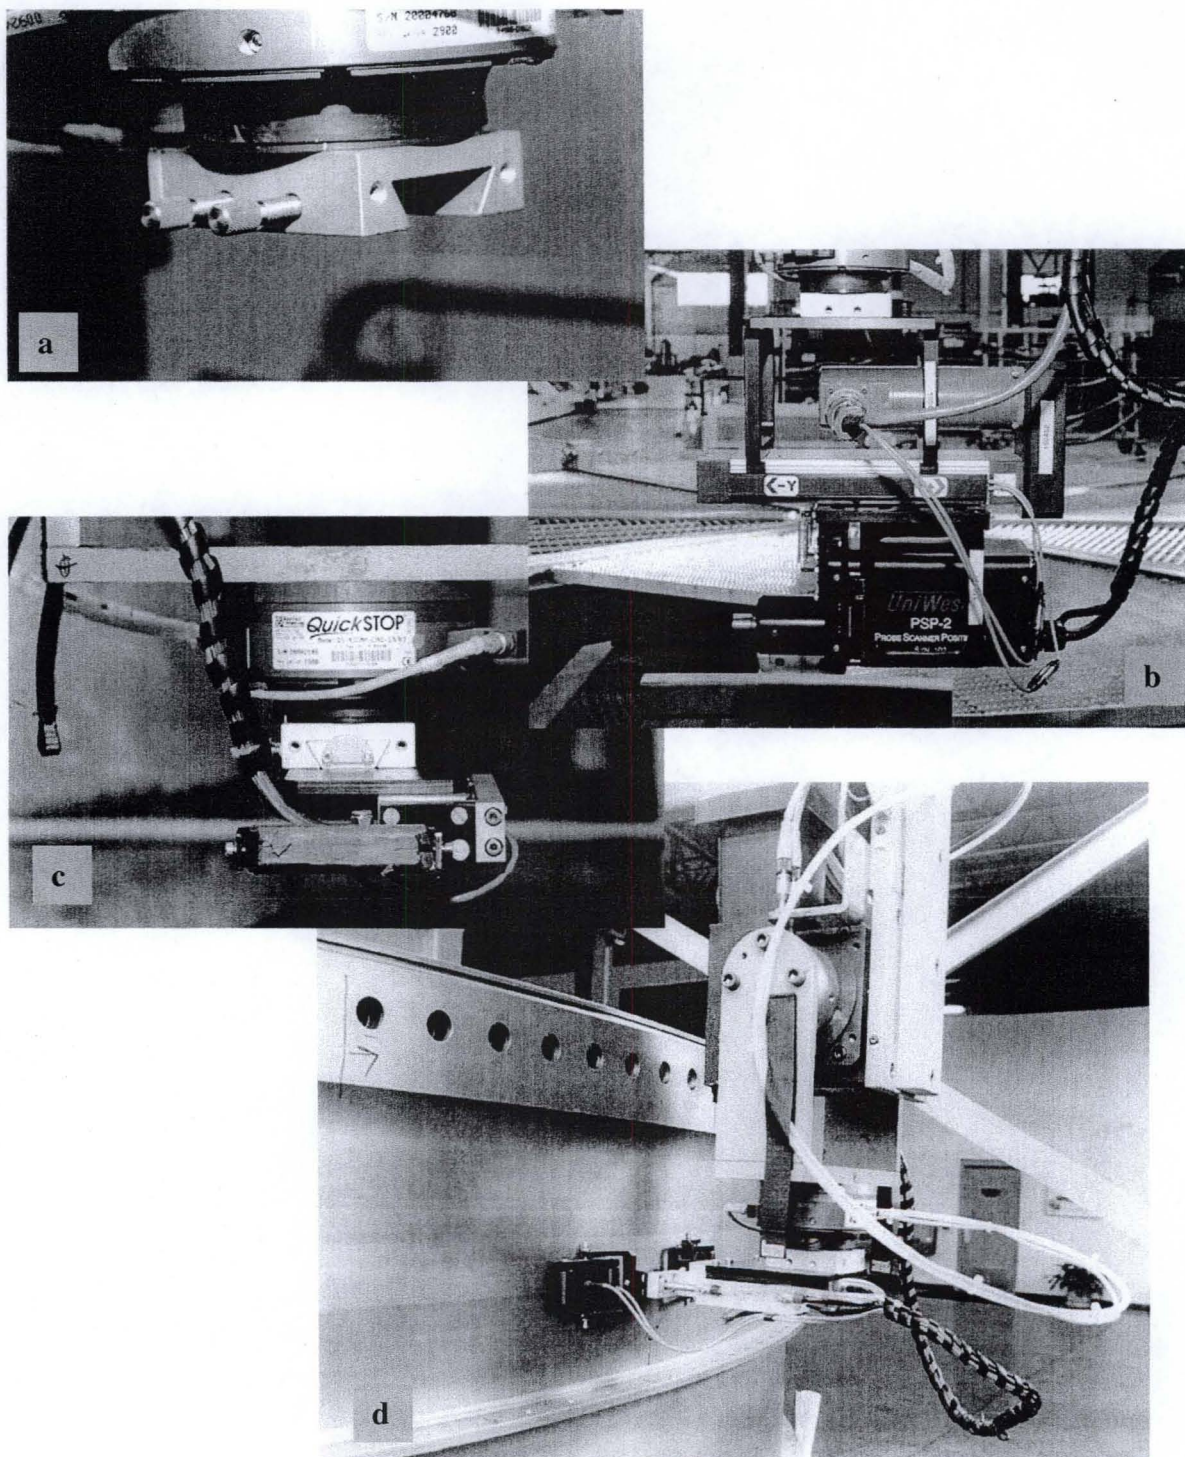
Figure 2: Various elements associated with AIIS: a) Dovetail joint to mount inspection sleds, b) mounted hole scanner, c) sled for "skiing" over holes, and d) sled for large acreages.

The AIIS is a sensor-based, robotic system and therefore has a great deal of control and repeatability, which is highly valued when working in the space program. All components and probes, some of which are shown in figure 2, are documented and controlled on tooling drawings. All RSRM parts are initially programmed and inspection coverage of required surfaces is verified. These programs and all associated software are controlled through a software configuration control procedure, assuring that all required surfaces are inspected the same way each time. The sensors are calibrated, assuring a measurable and consistent level of sensitivity and response. All calibration and detection "thresholds" are traced back to extensive Probability of Detection (POD) testing performed on actual cracks. This helps ensure that the required flaw sizes will be detected with a high level of statistical probability and confidence.

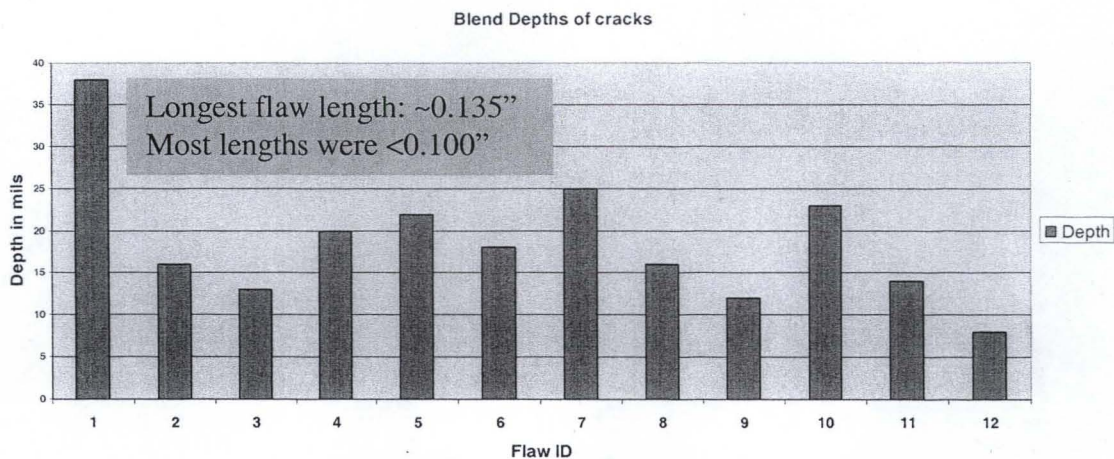
Figure 3: Summary of crack dimensions found on cylinder.

Cylinder	12 – ID membrane; circumferential & longitudinal orientations.	All very small (well below detection requirement for that area - see table 2).	All manufacturing flaws. Part was on 6 th refurbishment. Unable to visually detect.	All cracks were verified with local MT and blended out.

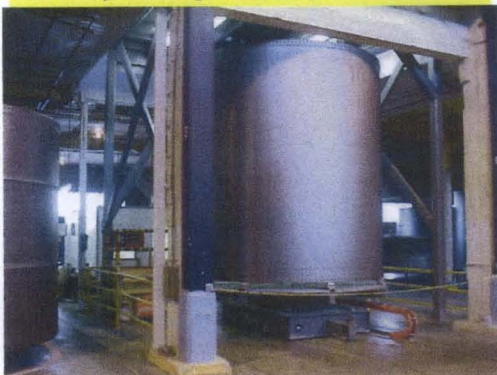
H-7 bay for large case cylindrical parts

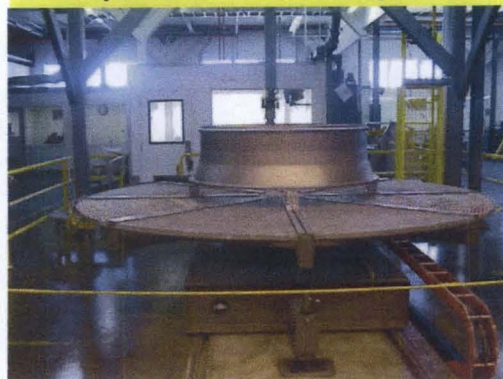
H-6 bay for smaller nozzle & igniter parts

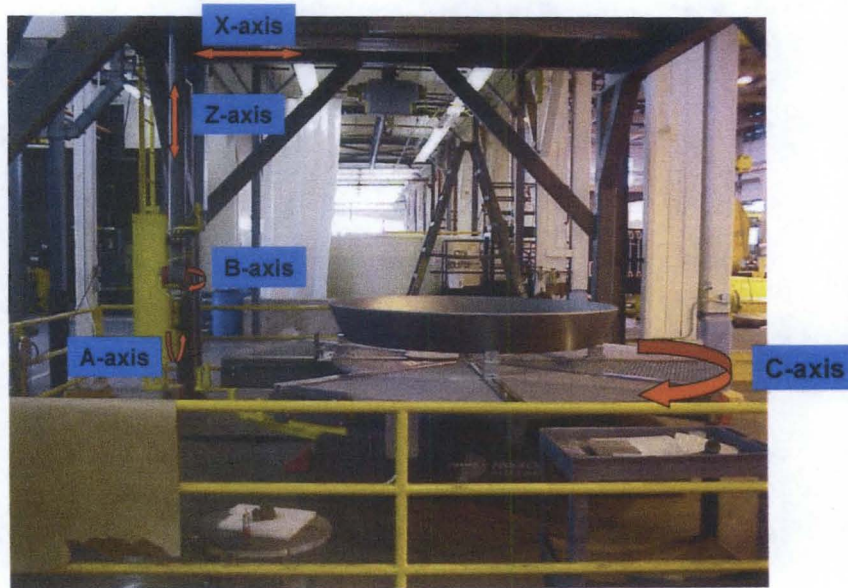
- AIIIS integrates a 5 axis robotic system with an eddy current data acquisition system

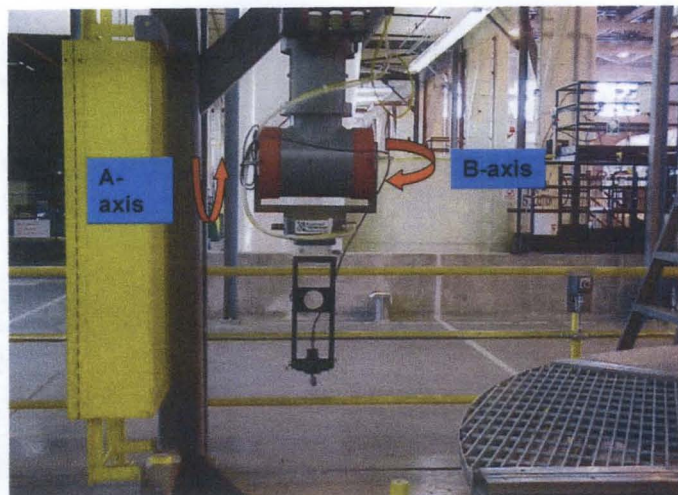
- Close up of inspection wrist

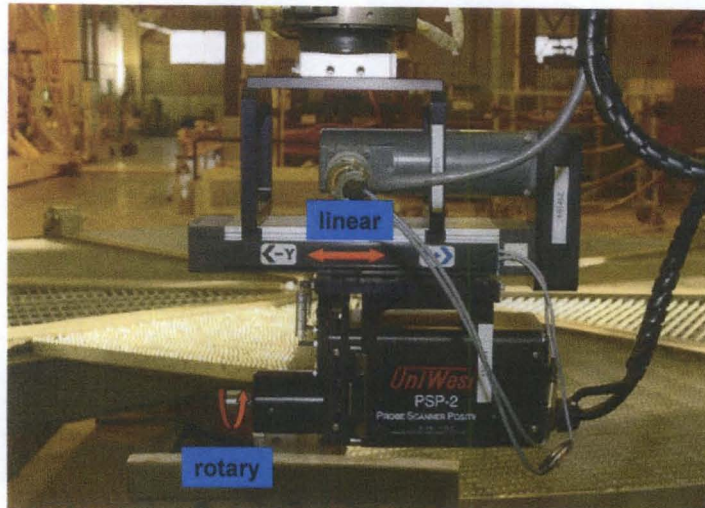
- For inspection of holes, a rotary scanner with linear drive is attached to the wrist (two additional axes of motion)

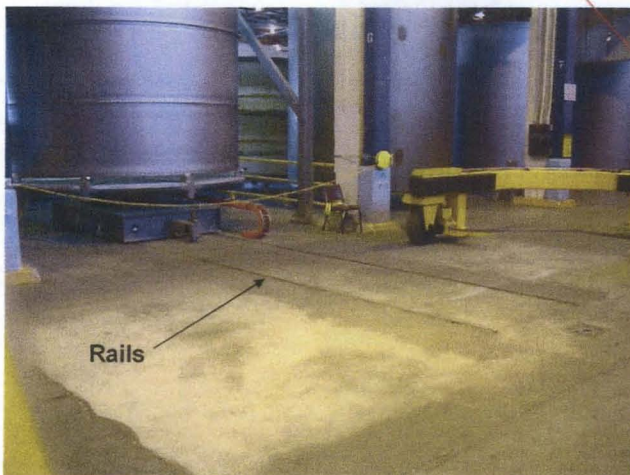
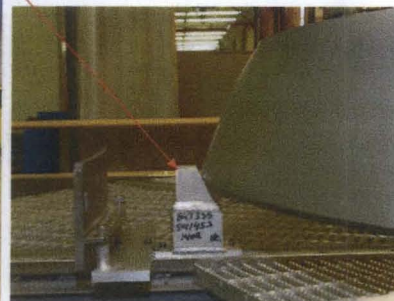
- The inspection turntable is on rails, and extends into the high bay for loading and offloading of components
- Components are mounted on adjustable chocks

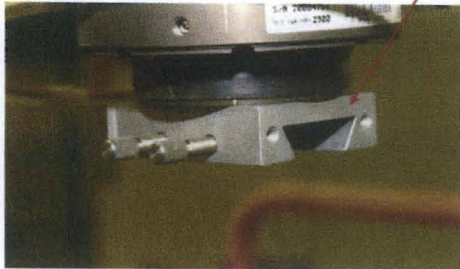
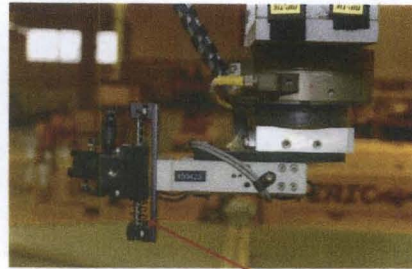
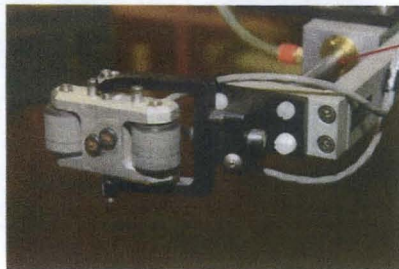
- Probes or inspection "sleds" used for different surfaces and geometries are mounted to the inspection "wrist" via a dovetail joint

Pneumatic pressure and spring tension help insure compliance to part

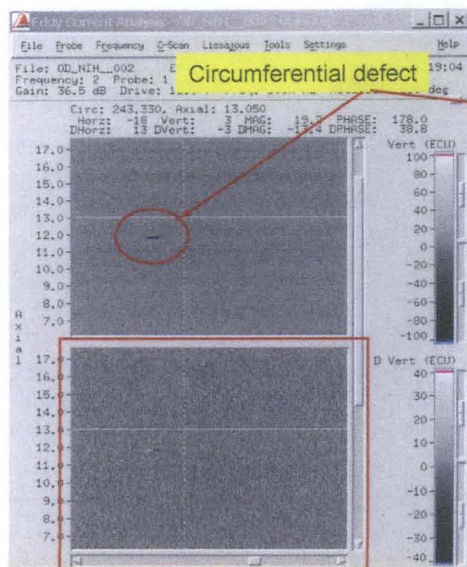
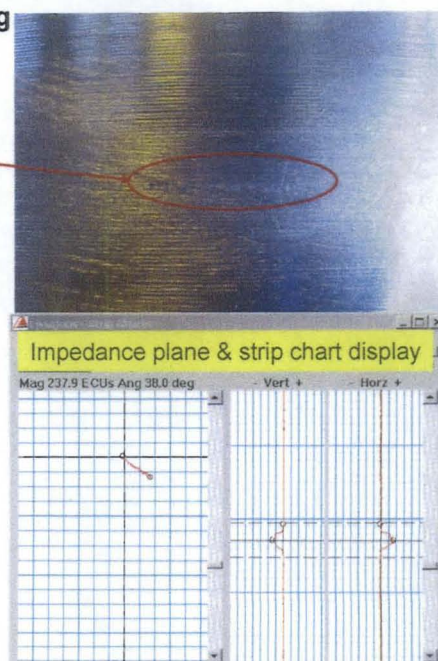
Aluminum Components - Nose Inlet Housing

- Three separate parts were found with shallow crack-like inclusions
- The very first part (a new part) inspected with the system was found to have several cracks
 - The part surface was machined and very smooth, but all the cracks were in conjunction with pitting (~0.005" deep)
 - Flaws were blended out – deepest was around 0.020"
- Two other refurbished Nose Inlet Housings have also been found with similar defects in the same region of the part,
 - The flaws were typically "long" (still less than 1") and shallow (deepest around 0.030")
 - They correlate with pitting
 - Some of the flaws were visually verified during removal (blending)
- All flaws were manufacturing flaws

Bottom C-scan is filtered image of top C-scan

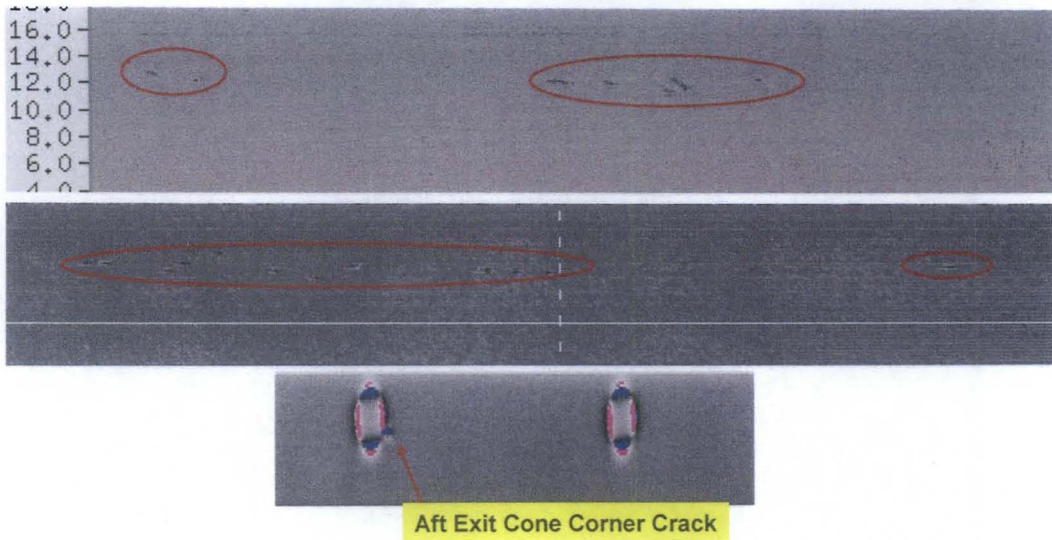
Aluminum Components - Two other Nose Inlet Housings had similar circumferential defects in the same region (OD membrane). Also, an Aft Exit Cone was verified to have a corner crack (part was initially inspected with penetrant)

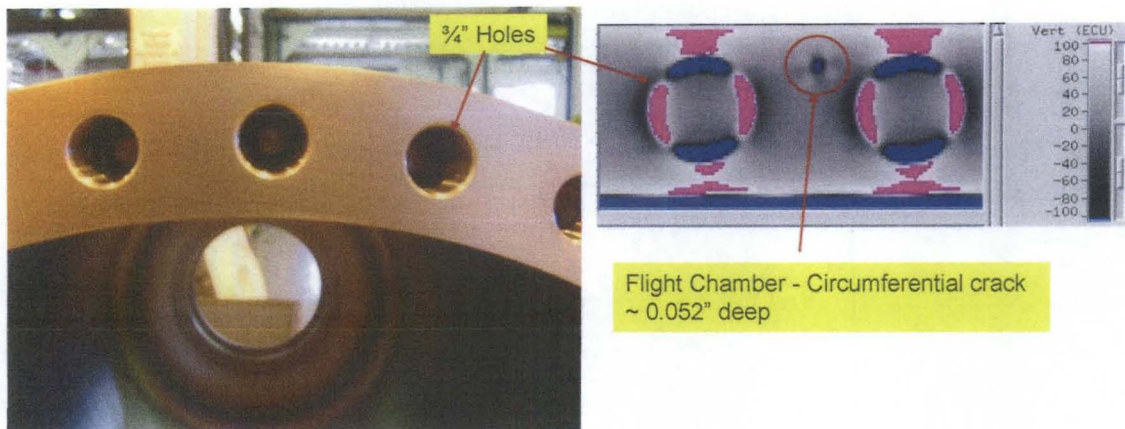
D6AC Steel Igniter Chamber

- Two separate parts found with flaws in the same region
 - One chamber dedicated for flight, the other for testing

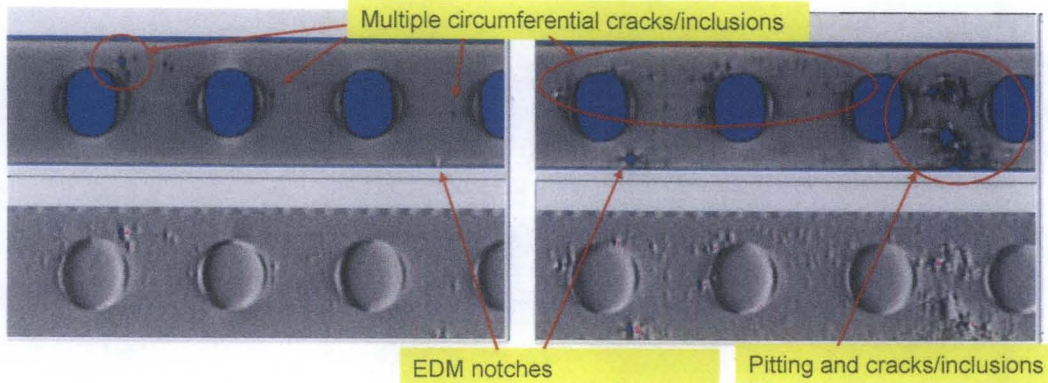
D6AC Steel Igniter Chamber

- Test article

- Bottom images are the same as the top but they are filtered (differentially)

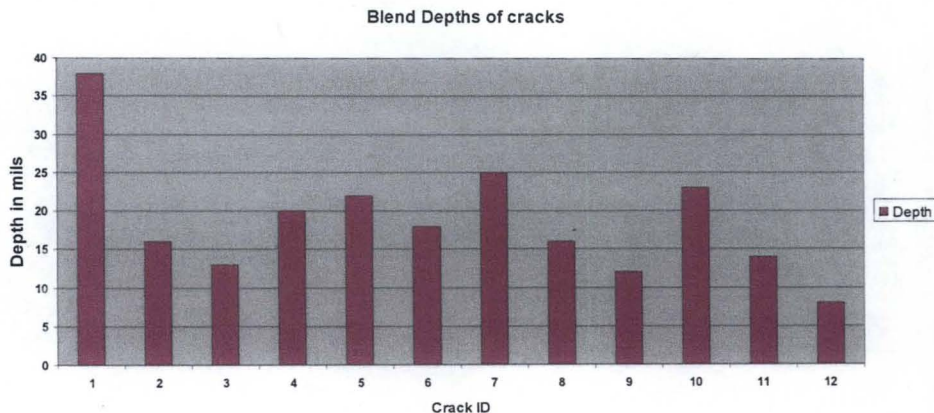
D6AC Steel Cylinder (Case Component)

- On it's 6th refurbishment (i.e., had been inspected multiple times over the years)
- Detected 12 small cracks on the ID membrane of the cylinder
- All cracks were manufacturing flaws with different orientations
- Lengths were on average around 0.100" or smaller (required detection level was 0.250" by 0.125" deep). Depths are summarized below

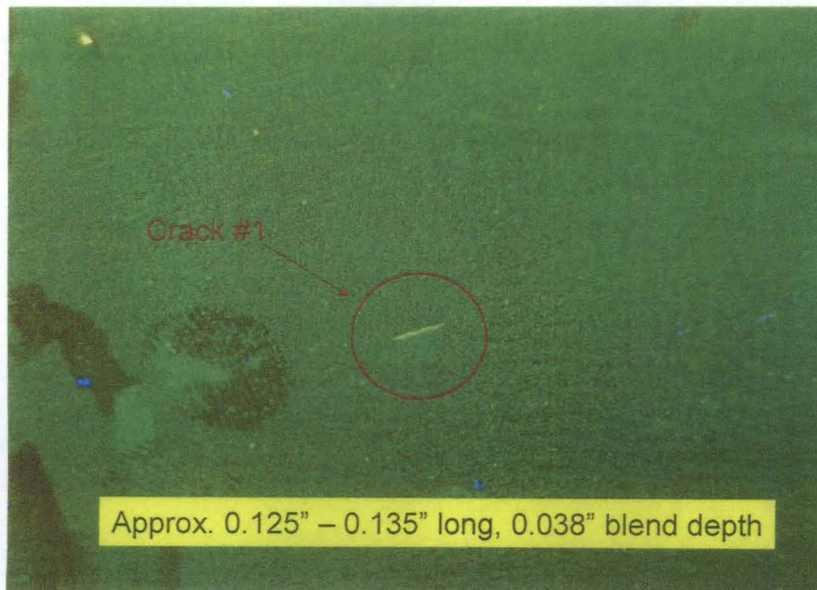
Crack #1: Mag image of crack using portable yoke with wet fluorescent spray

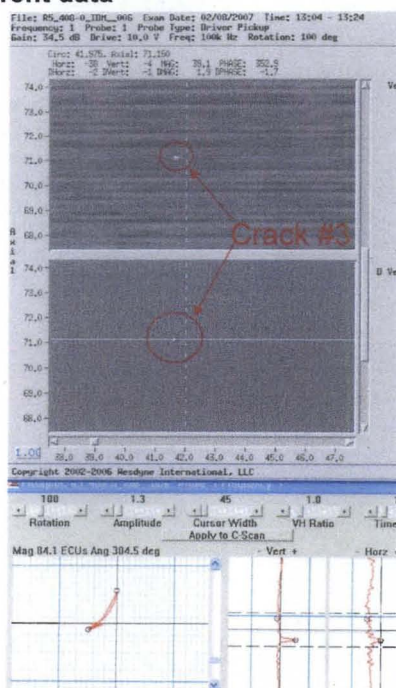
Crack #3: AIIIS eddy current data

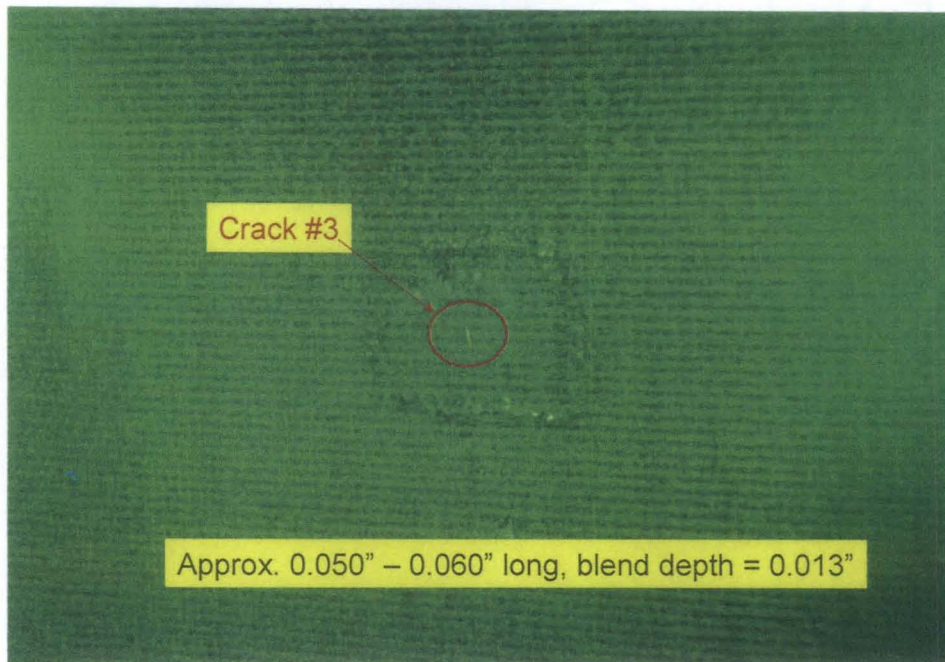
Crack #3: Wet fluorescent mag image

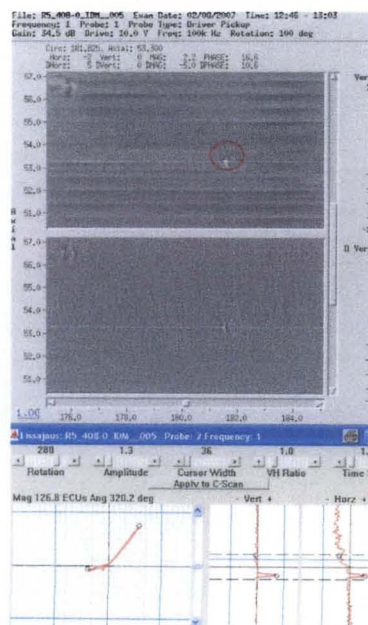
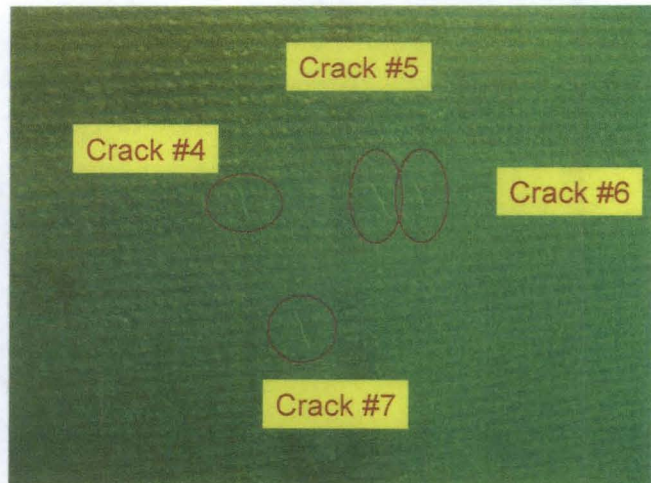
Crack #s 4-7: AIIIS eddy current data & mag image

Blend Depths for cracks

#4: 0.020"

#5: 0.022"

#6: 0.018"

#7: 0.025"

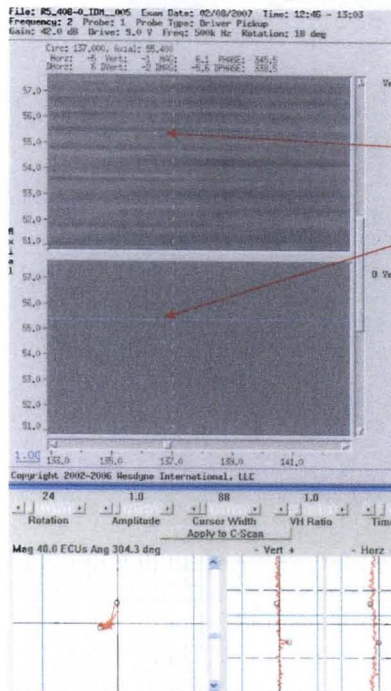
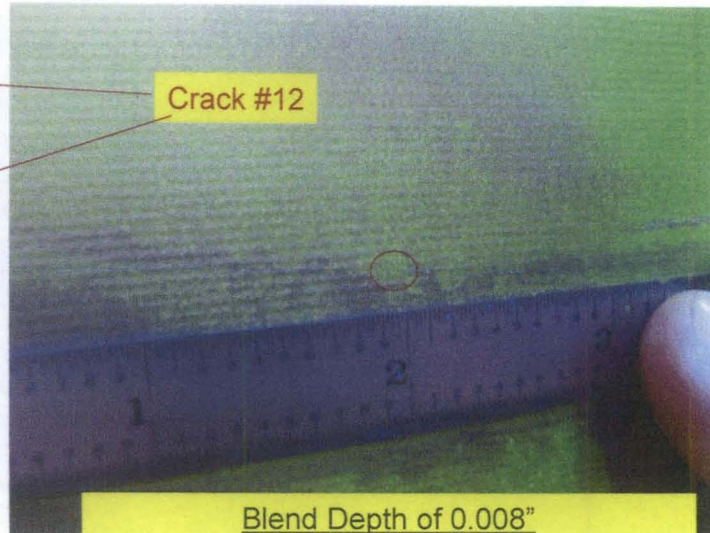
Crack #12: AIIIS eddy current data and mag image
